CEPRA Beach Monitoring Phase 8 Surveys and Analysis: 2017 Monitoring Year Volume 2

August 31, 2018 (Revised October 11, 2018)

TGLO Contract: CEPRA Contract 13-401-000 Work Order A656

Conrad Blucher Institute for Surveying and Science
Texas A&M University-Corpus Christi
6300 Ocean Drive, Unit 5799
Corpus Christi, Texas 78412

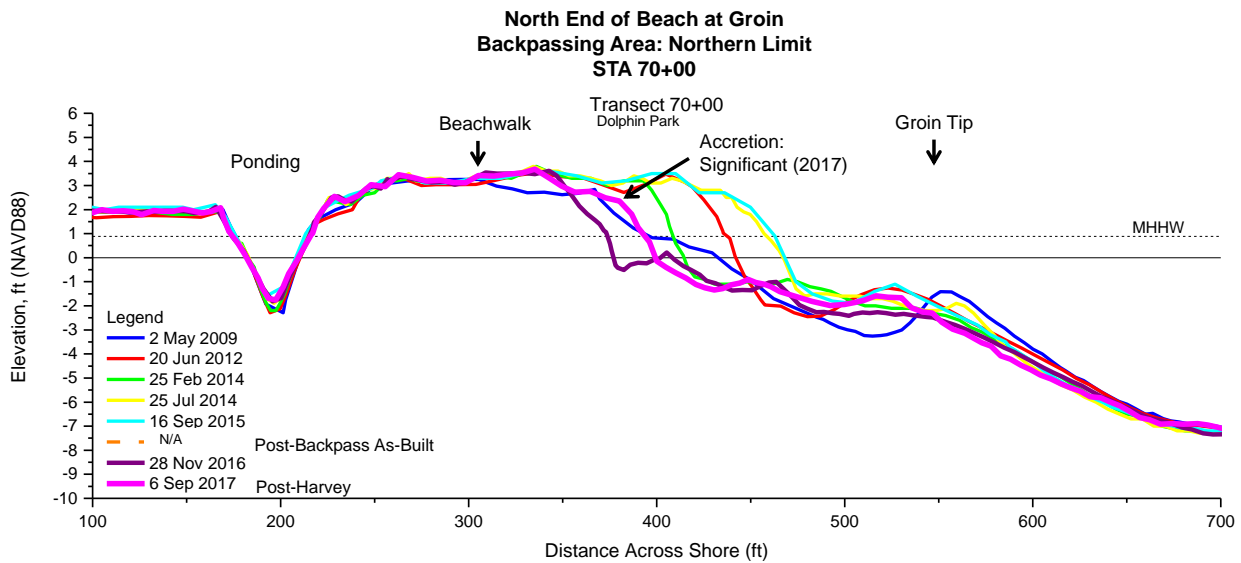
Figure 13. Maximum accretion and increase in beach width documented near terminal groin between Nov 2016 and Sep 2017

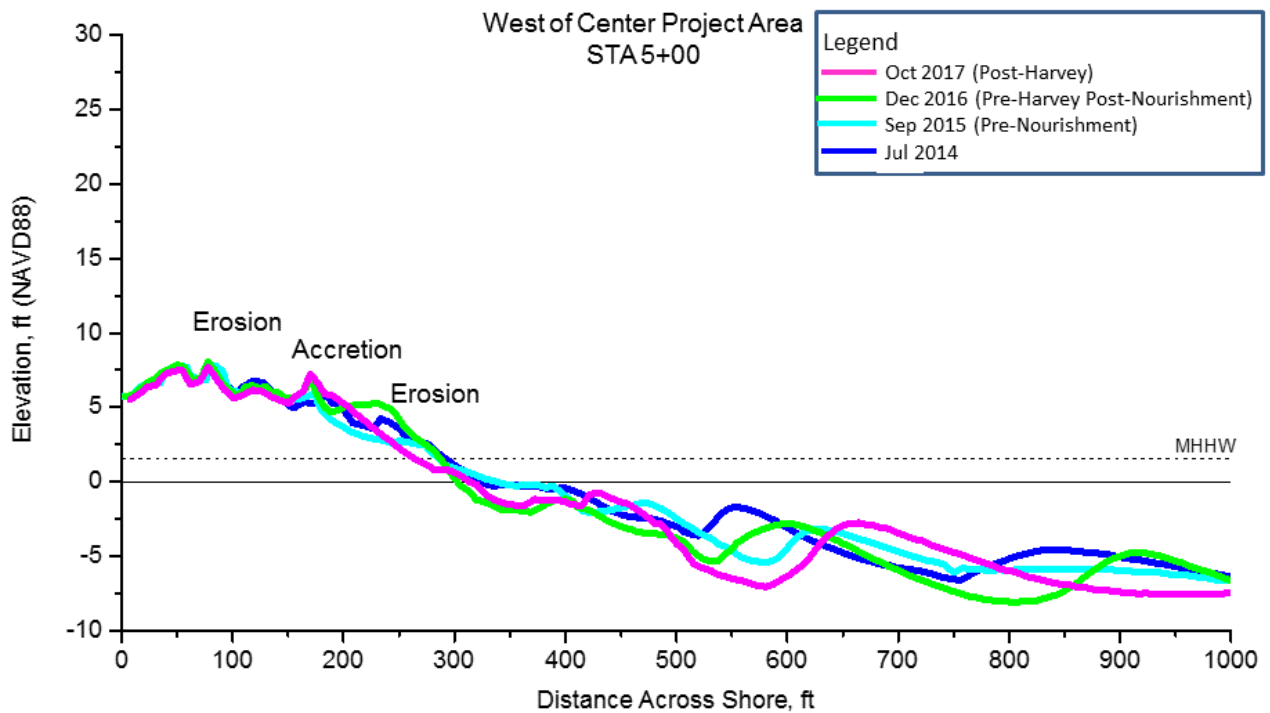
Figure 16. West of Center Project Area: Significant erosion across berm crest and foreshore. Erosion landward of accreting primary dune (2017)

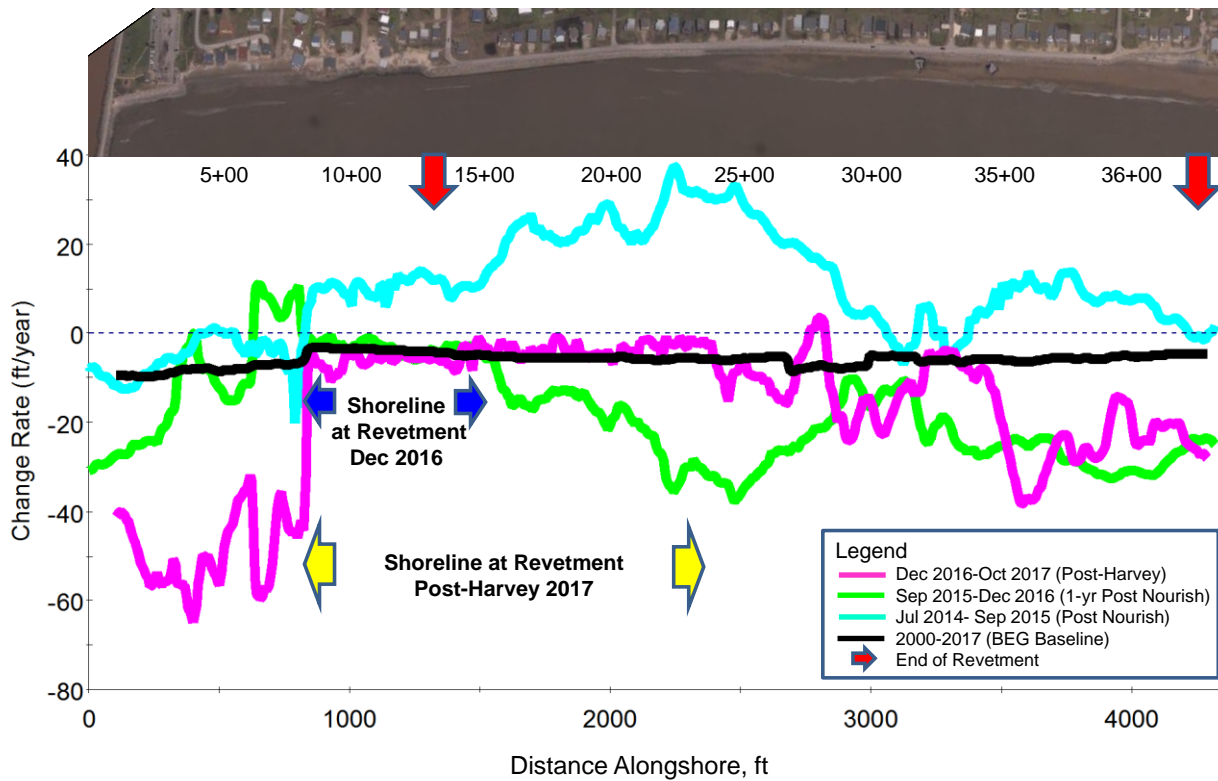
Figure 110. Comparison of variability in the rate of shoreline change with alongshore position in the Project Area over key intervals 1) Post Harvey (2016-2017) after nourishment (2015) and after Harvey (2017)
